Manhole Inspection Summary

Manhole # S05II2008MH

Insp Date: **8/2/06 12:00 AM**

Location Address: **6300 SHELICK DR**

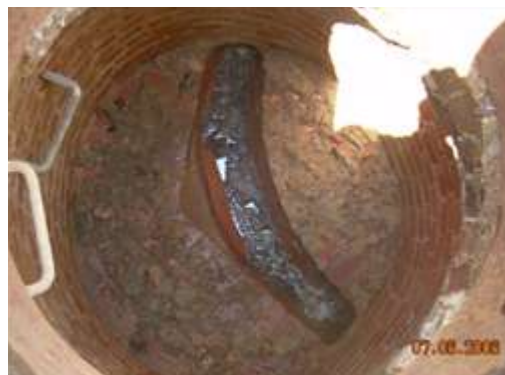
Top View

Frame leaks. Adjustment deterioration and loose brick. Adjustment infiltration. Evidence of surcharge - Bench debris.

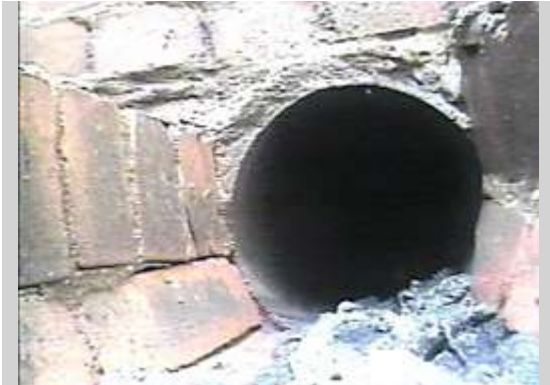
8 in. Circular Gravity Sewer Pipe Out @ 12 O'Clock

Deposits: ☐ None ☐ Mud ☐ Sludge ☒ **Debris** ☐ Grease

Silt Depth: **0.5** (in.) Deposits Extent: **Light**

Infiltration: **None** Pipe Seal Cond: **Unknown**

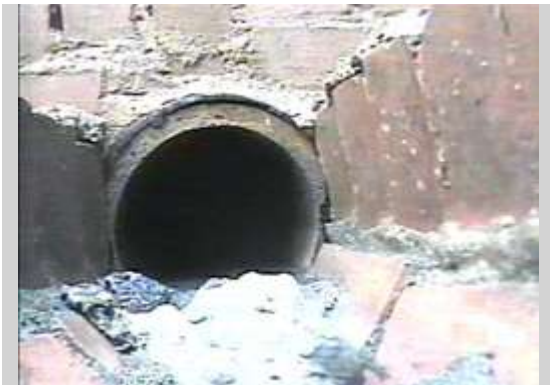
6 in. Circular Gravity Sewer Pipe In @ 5 O'Clock

Comments **The I5 pipe seal is not flush to the pipe. The I5 pipe picture shows Channel debris and grease deposits.**

Deposits: ☐ None ☐ Mud ☐ Sludge ☒ **Debris** ☐ Grease

Silt Depth: **1** (in.) Deposits Extent: **Light**

Infiltration: **Evidence** Pipe Seal Cond: **Unknown**
